## A Survey of Thatched Buildings in Scotland

Thatch Survey of Scotland  
2014-15

A photographic survey of thatched buildings in Scotland, surveyed between May 2014 and August 2015 by Zoe Herbert (SPAB Scotland Officer), on behalf of the Society for the Protection of Ancient Buildings.

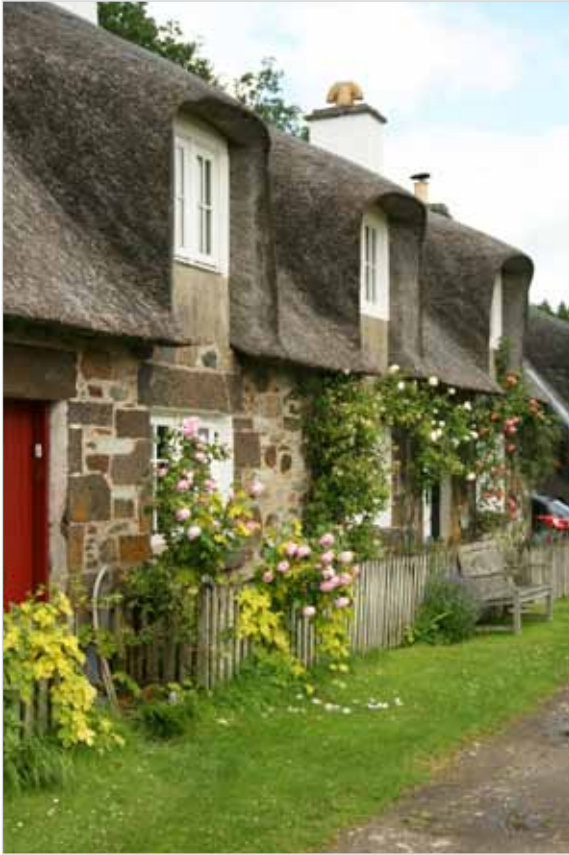
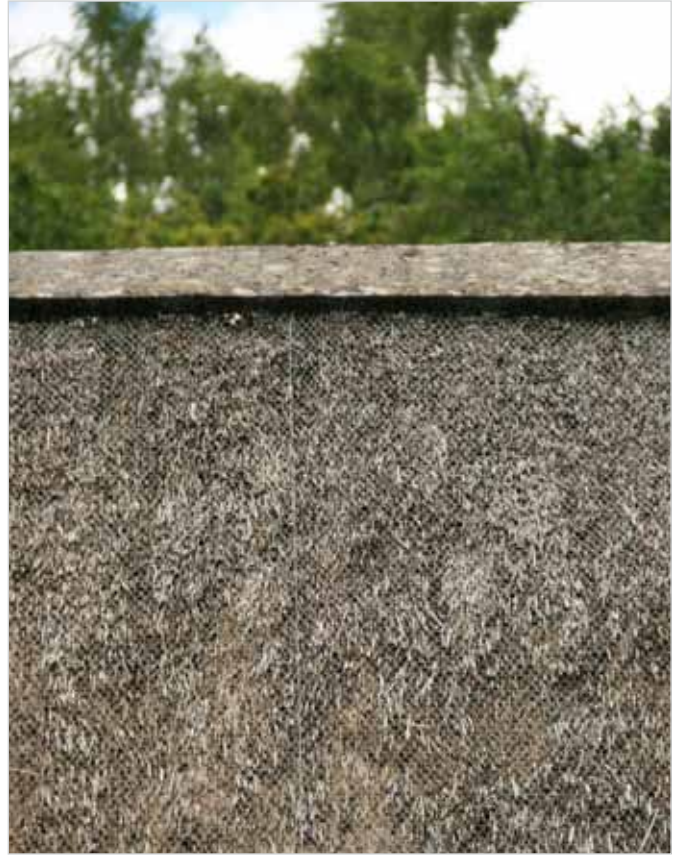
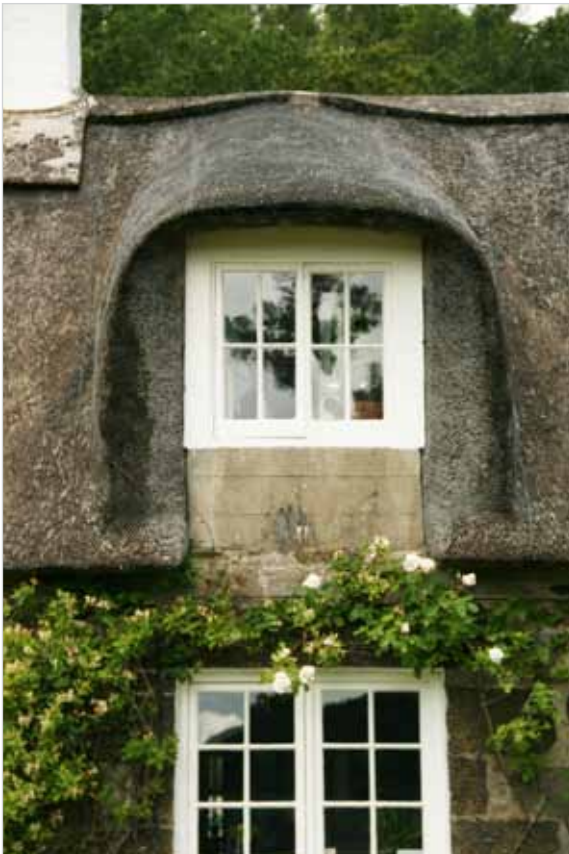
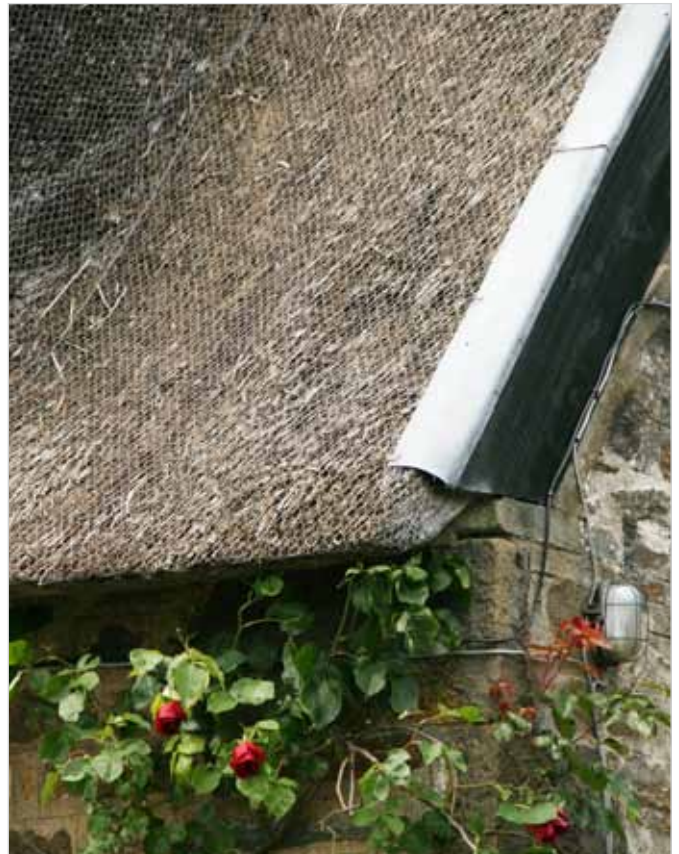
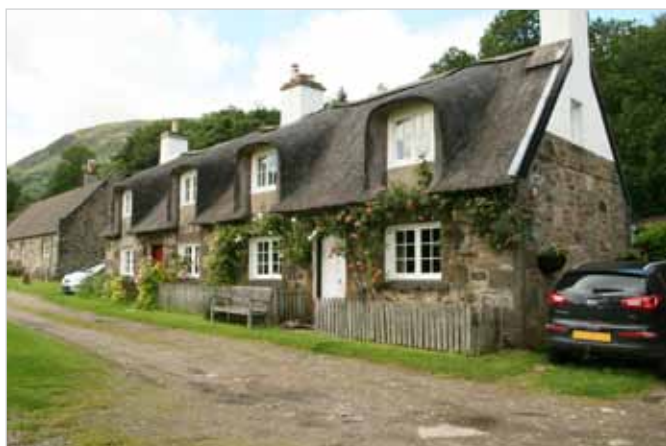
West Cottage – Perth & Kinross

Condition of Thatch: ..... Good

Additional Notes: Circa 1900 single-storey cottage with attic and four dormer windows on the front elevation, listed as being thatched and by architects Dunn & Watson. The reed-thatched roof has a concrete ridge, which is raised above the dormer windows to accommodate the curve in the structure. The ridge also extends directly below each of the three chimney stacks, one at each gable end and one along the ridge. The thatch has been entirely netted and has been boxed in with timber and lead flashings at the skewes.

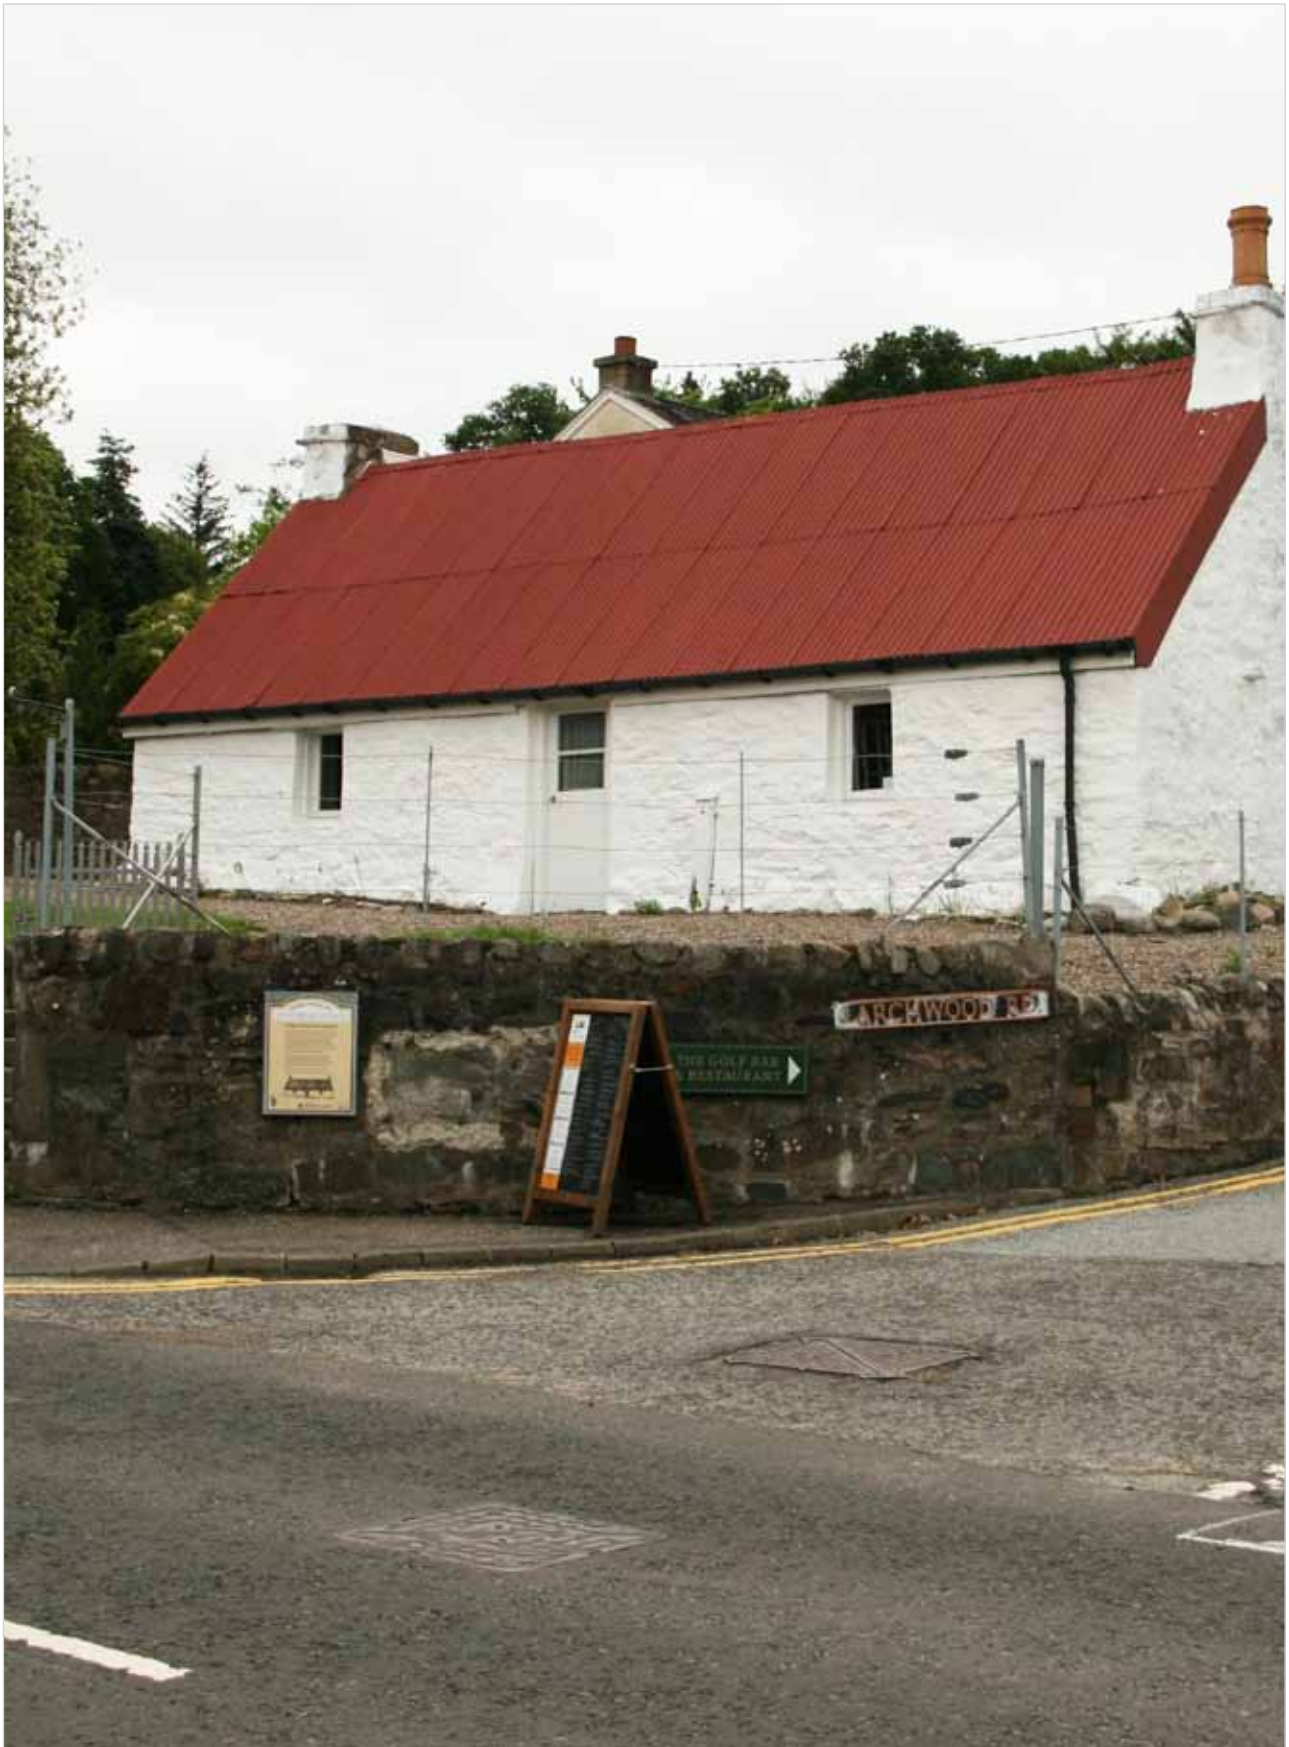
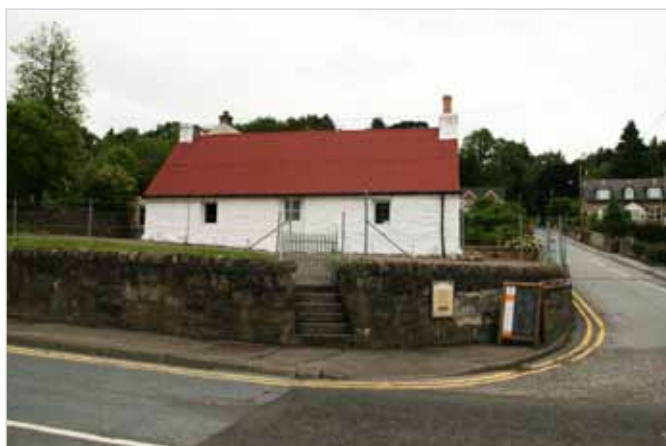
Sunnybrae Cottage – Perth & Kinross

Condition of Thatch: ..... Unknown

**Additional Notes:** ..... Late 18th to early 19th-century cottage, listed as having thatch surviving underneath its corrugated iron roof. Historic Environment Scotland bought the building in 1998 after the death of its last owner and according to the website it has 'carried out an extensive programme of conservation, archaeological excavation and research, which has illuminated the intriguing history of this building and its inhabitants'. The building is currently closed to visitors, and the interior was therefore not inspected. The listed building notes read '*thatch (much repaired) consisting of variety of materials, layers include cereal straw, some light grey clay,*

*grassy turves (laid grass side down), rye straw and broom twigs. Supporting cabers of small-diameter pine and birch*'.

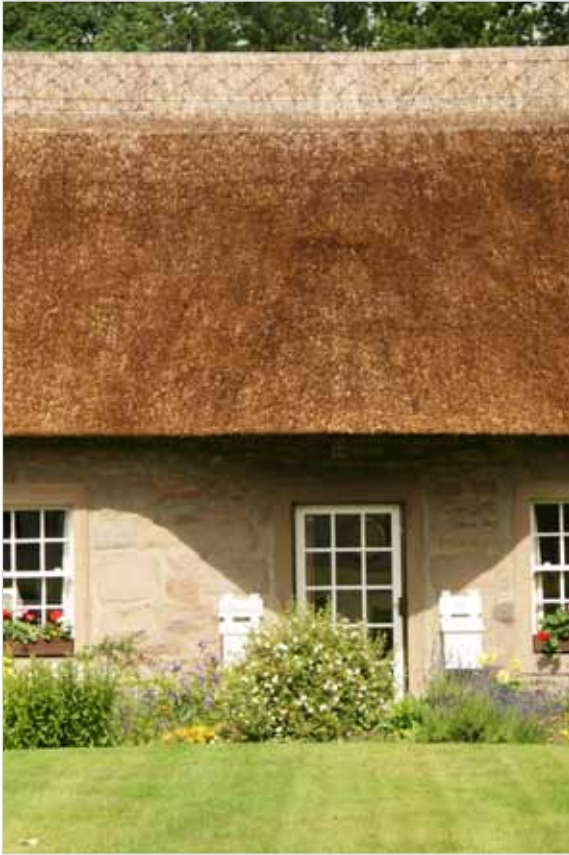
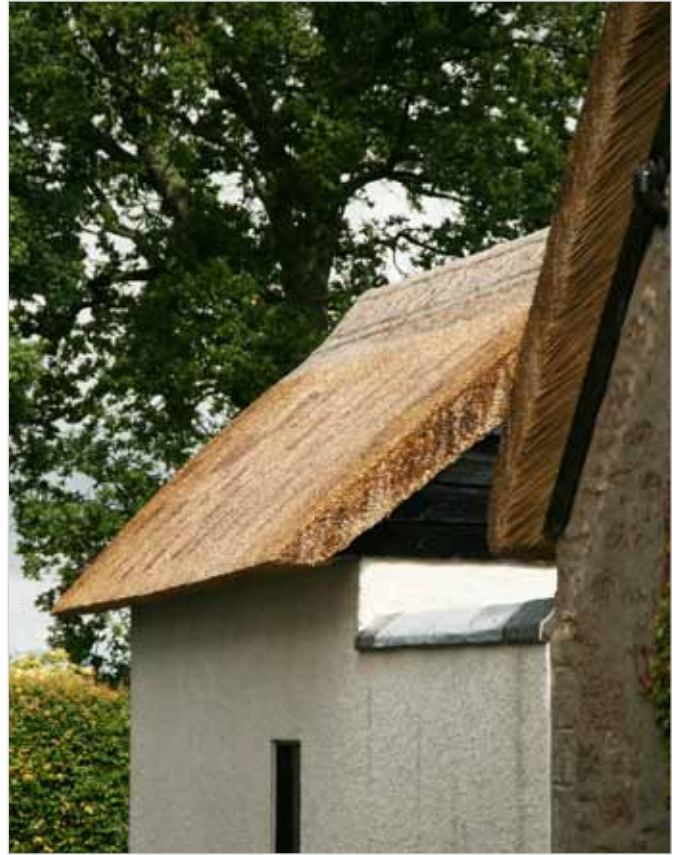
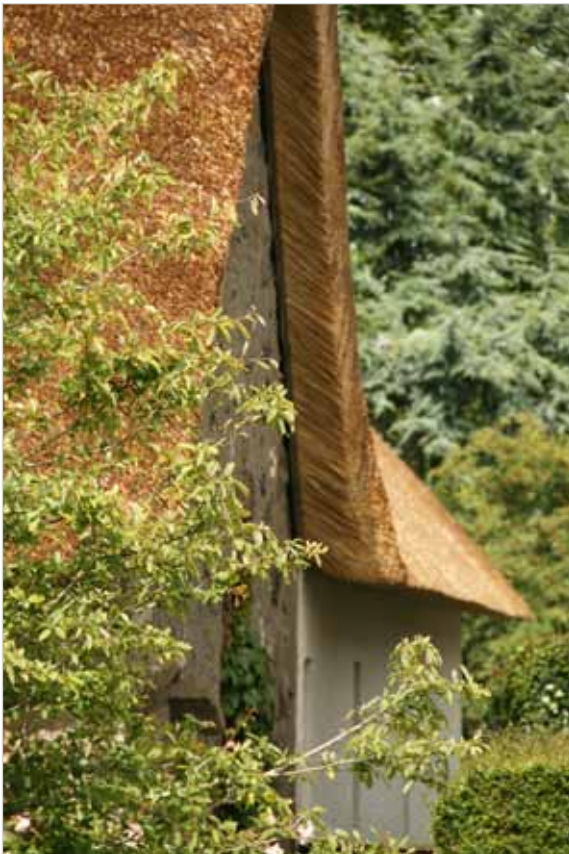
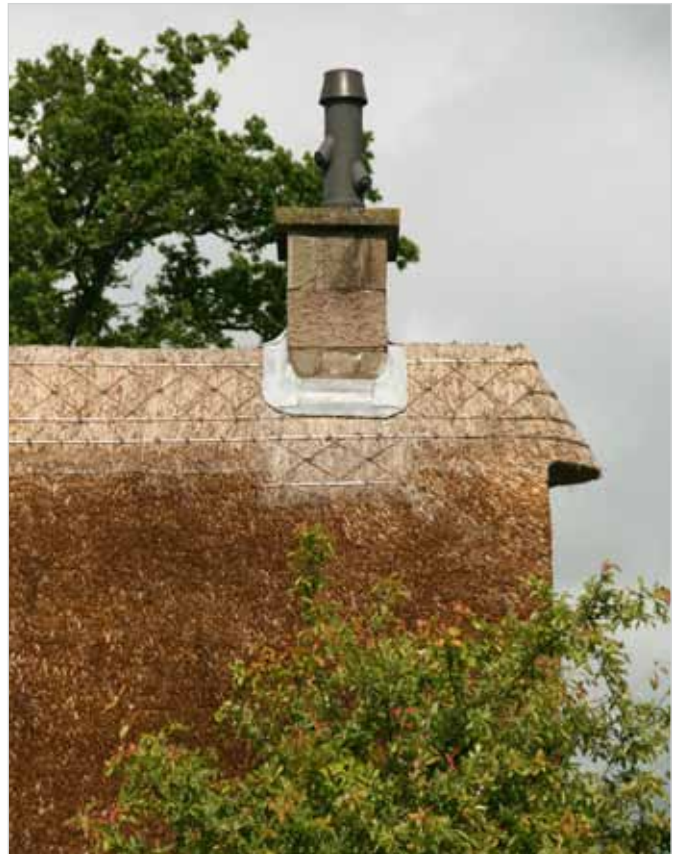
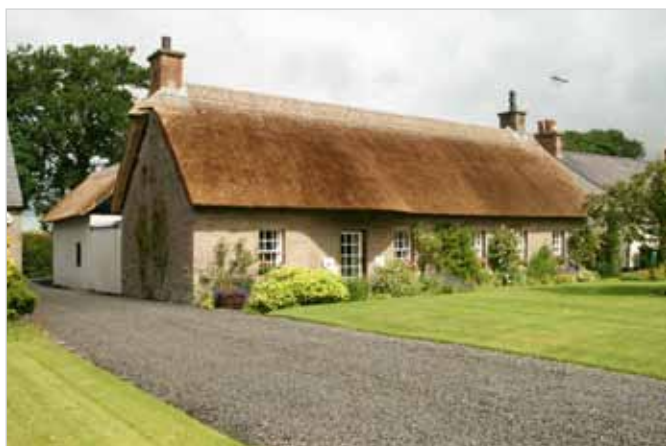
Mercat Green Cottage – Perth & Kinross

Condition of Thatch: ..... Good

**Additional Notes:** ..... Late 18th-century cottage, listed as having a 'roof thatched with corrugated iron over'. The cottage appears to have been extended to the north-west and renovated, has had the corrugated iron covering removed and a new thatched roof installed since being listed. The roof is thatched in reed with a straw ridge. The ridge, and below the chimney stacks, has been scobed with hazel spars and has been netted, whilst the rest of the thatch has been left uncovered. There is an extension wing to the rear of the building, projecting west from the north end, and an additional detached building to the south end, which is connected to the main cottage

by a single wall. Both of these additional buildings have been thatched in the same way as the main cottage.

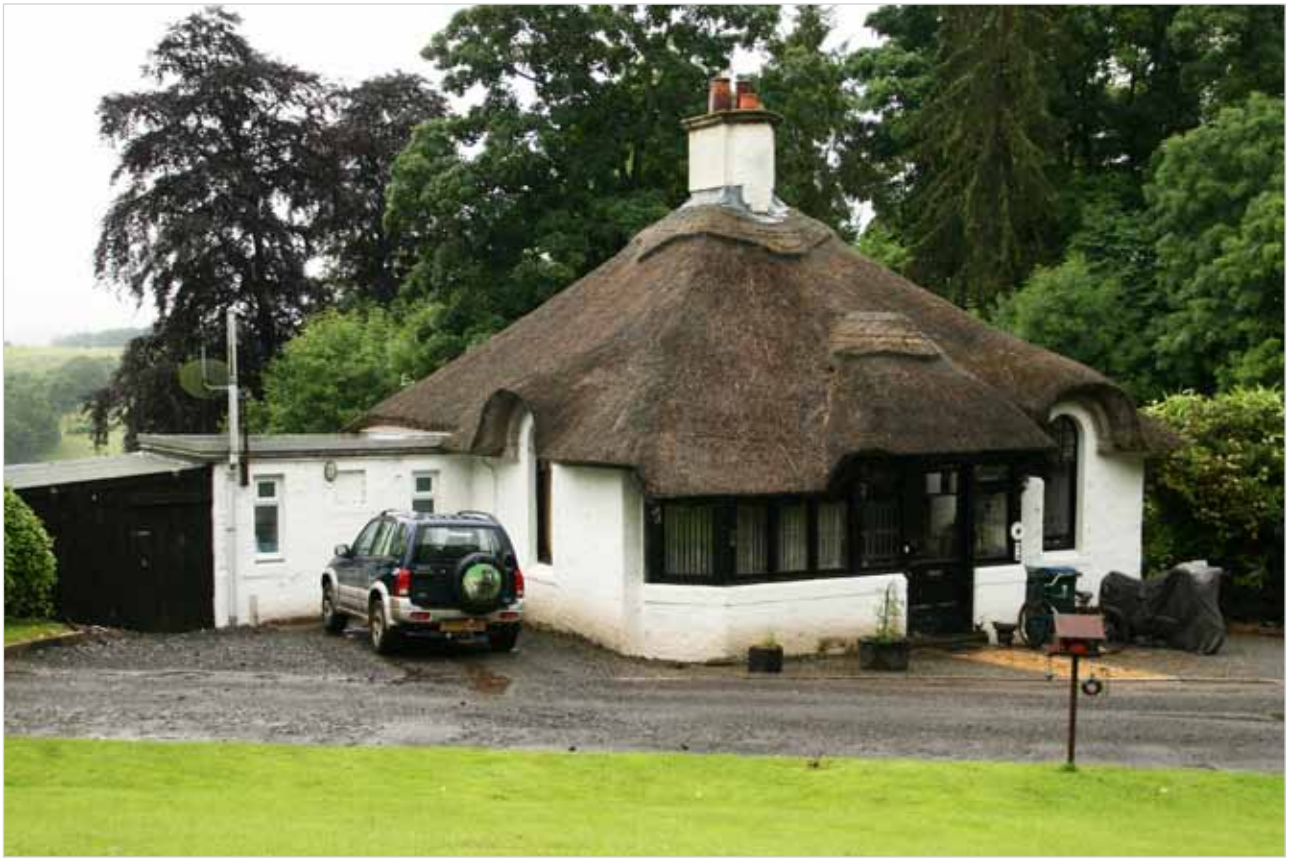
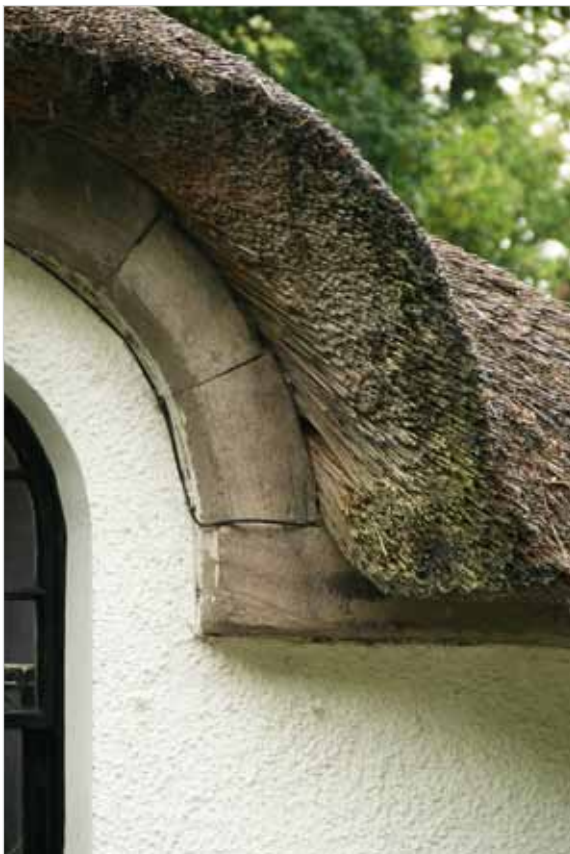
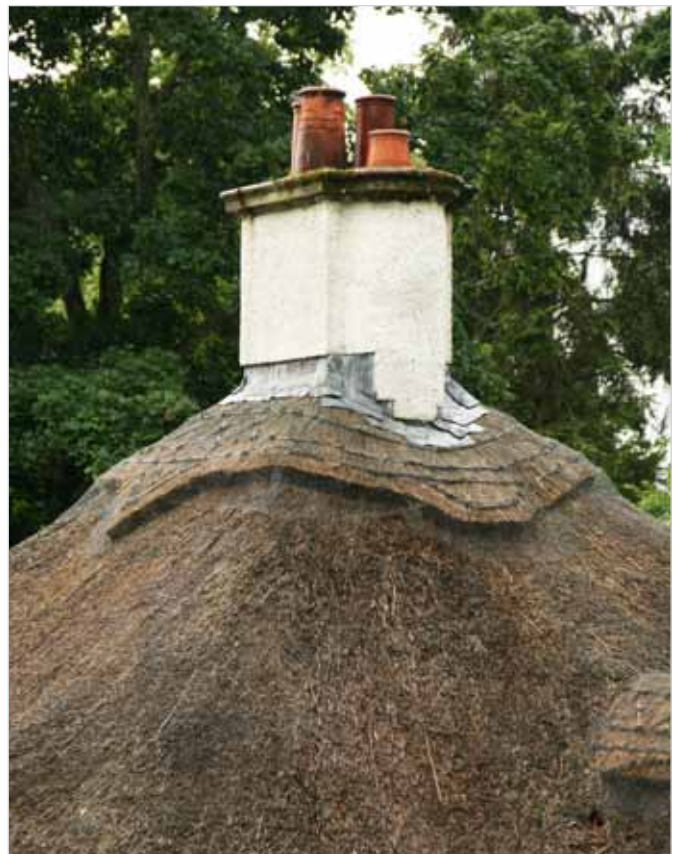
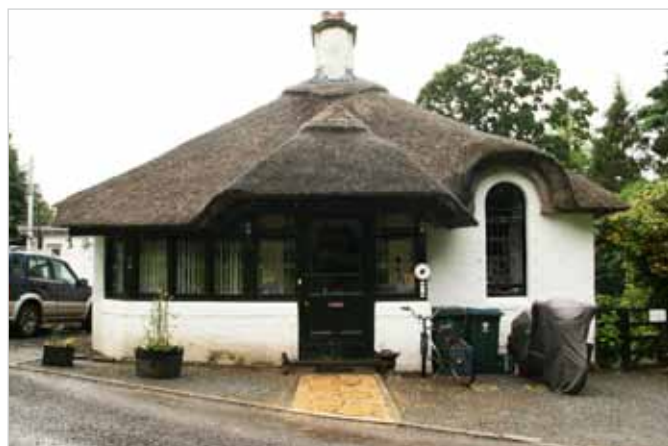
Balthayock Lodge – Perth & Kinross

Condition of Thatch: ..... Good

netted whilst the rest of the thatch has been left uncovered. There are some loose pieces of thatch in places;

however, this is not extensive. ....

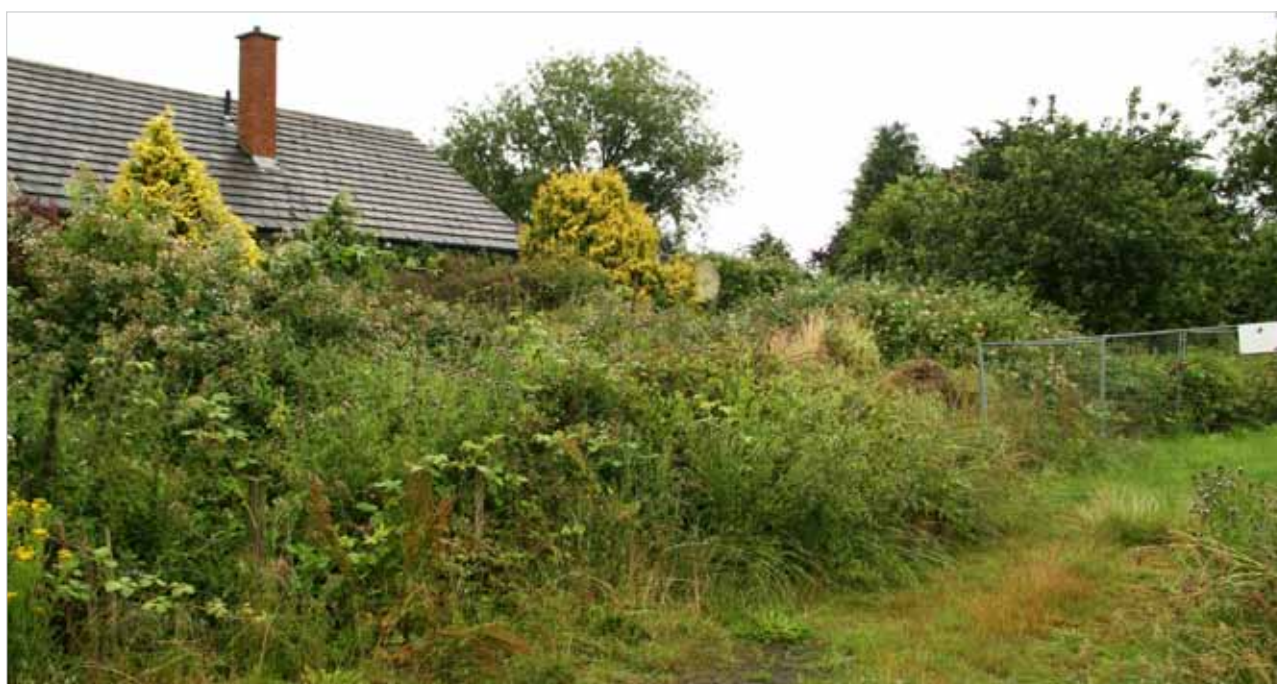
Address: ..... Cottage (Mrs Reid)

**Additional Notes:** ..... 18th/19th-century cottage and shed, listed as being thatched, though the listing does not specify whether both structures are supposed to be thatched. The listing notes state that the 'shed roof [is] in poor repair'. The grid reference shown in Canmore is incorrect and relates to a site in the middle of the road (no adjacent buildings appear to match listing description), whilst the location given by listing shows the site below. The buildings are now ruinous and heavily overgrown with vegetation and only some of the stone can be seen. The location should be clarified and the listing description updated accordingly.

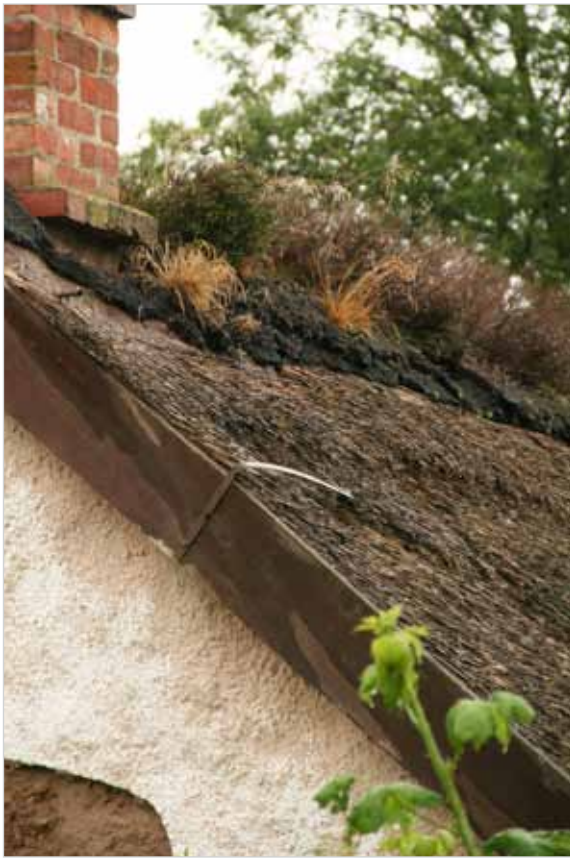
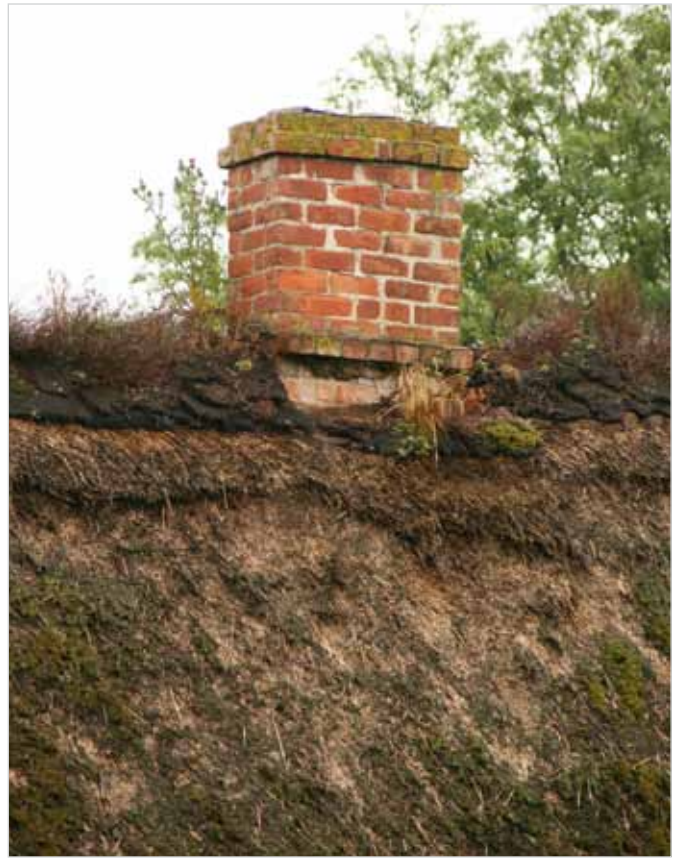
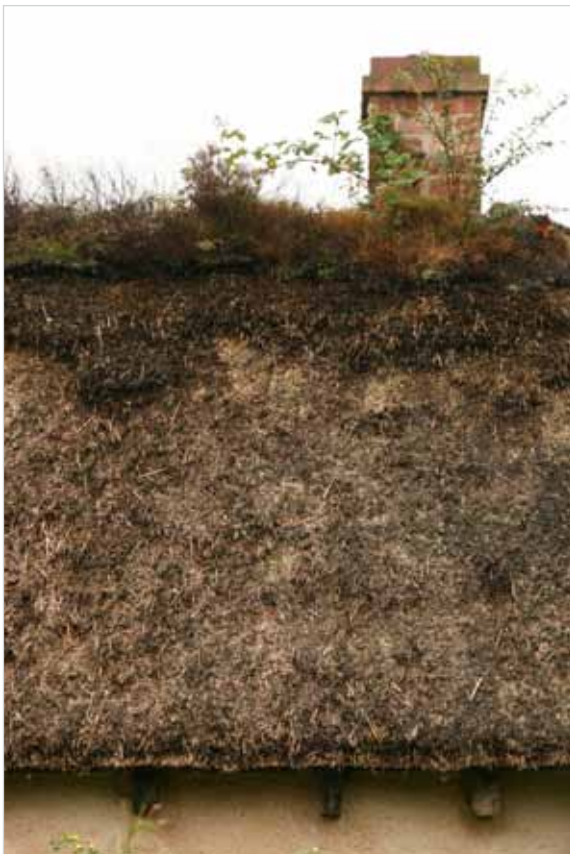
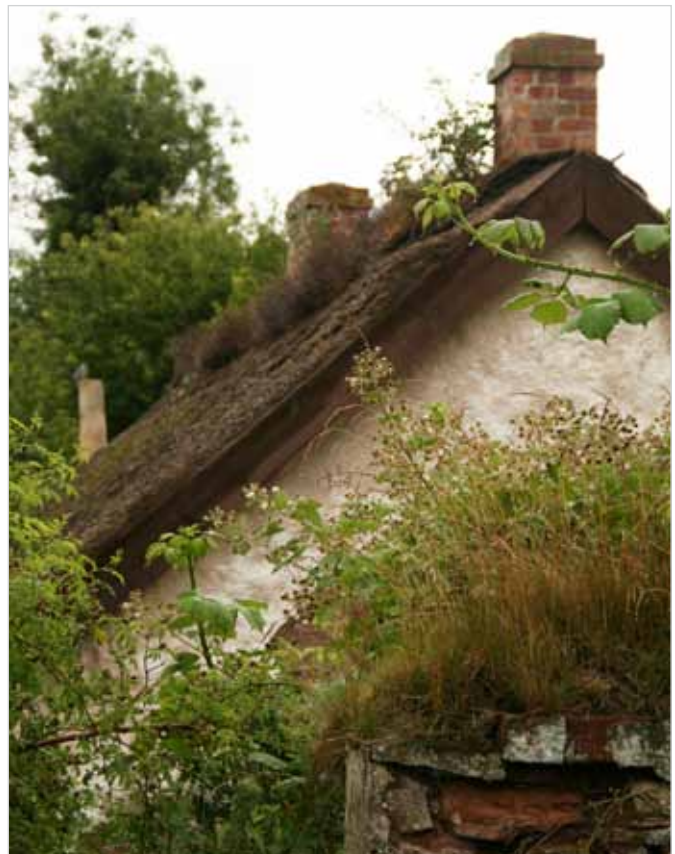
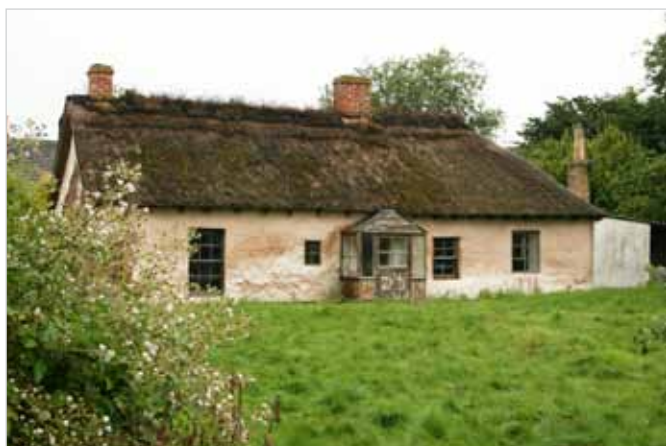
Cottown Schoolhouse – Perth & Kinross

Condition of Thatch: ..... Poor

**Additional Notes:** 18th-century clay-walled former school building, listed as having a thatched roof. The building has been on the Buildings at Risk (BAR) Register since 1991 (BAR reference number 312), at which time it was recorded that the '*thatch requires attention*' and that the building was occupied until 1985. In 1994, BAR recorded that the building had been acquired by the National Trust for Scotland and a restoration project was in progress in partnership with Historic Environment Scotland and Perth and Kinross Heritage Trust. In early 2011 the building was heavily flooded and it was recorded by BAR that the roof is '*in need of extensive repair and*

*there are dense growths of brambles*'. The roof is currently in much the same condition and has a large amount of mossy vegetation growth across the surface of the thatch, as well as vegetation growth in the turf ridge. The thatch has been left uncovered and is boxed in at the skewers with timber. The thatch is also supported underneath the eaves with timber.

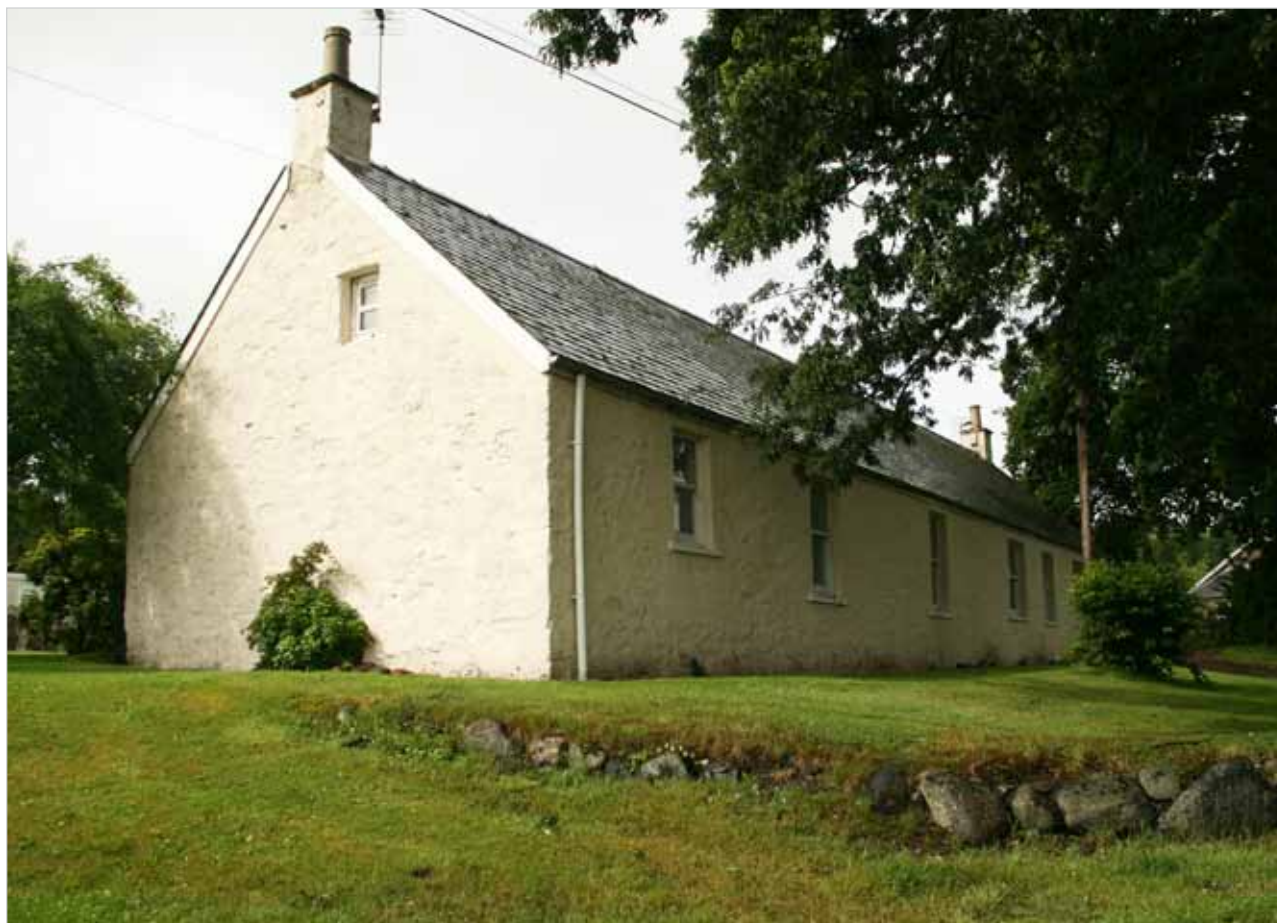
Additional Notes: ..... 18th-century cottage, listed in 1971 as having a thatched roof. The building now has a slate roof. The listing description for the building should be updated accordingly.  
.....

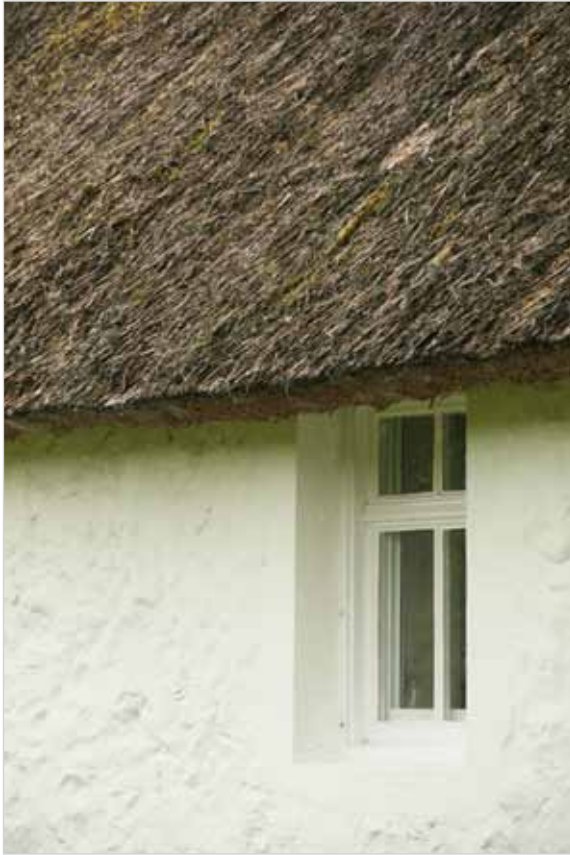
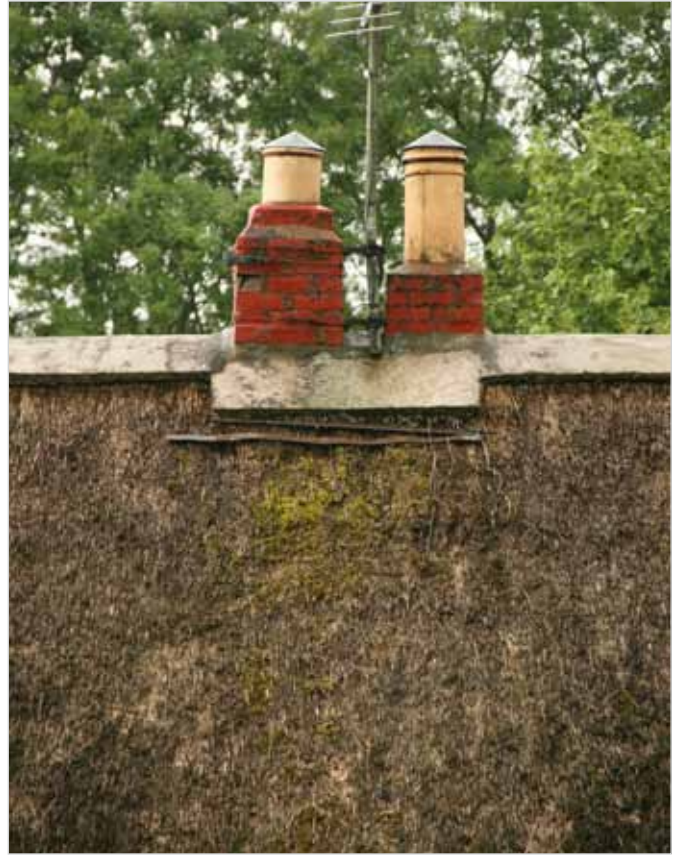
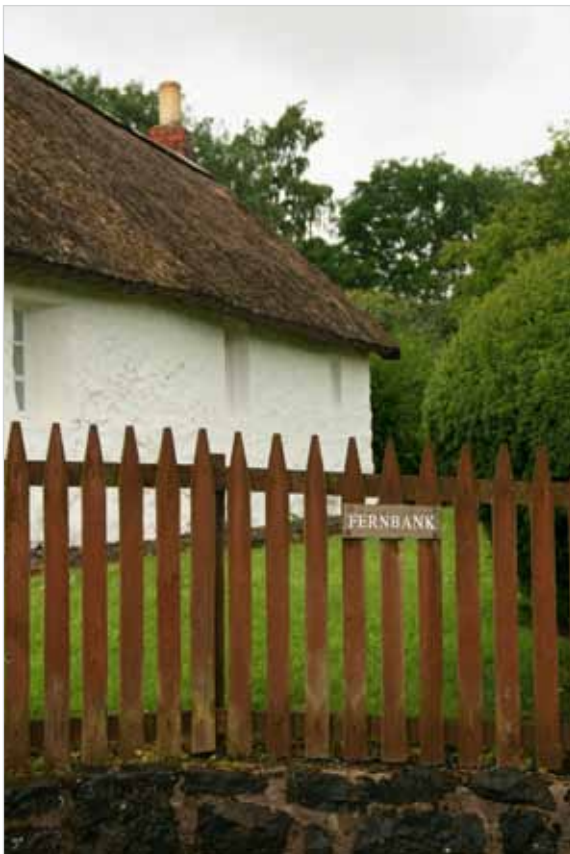
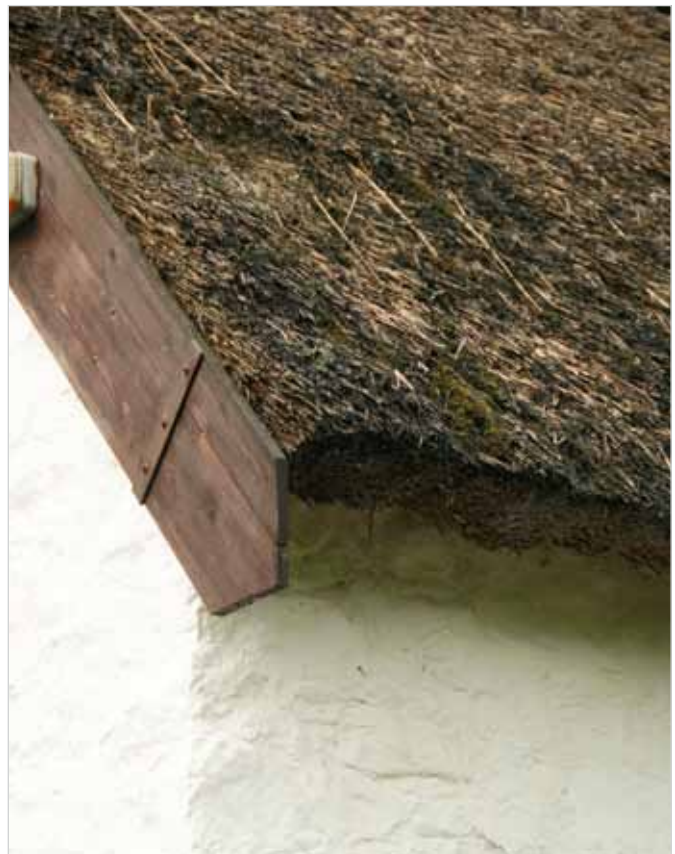
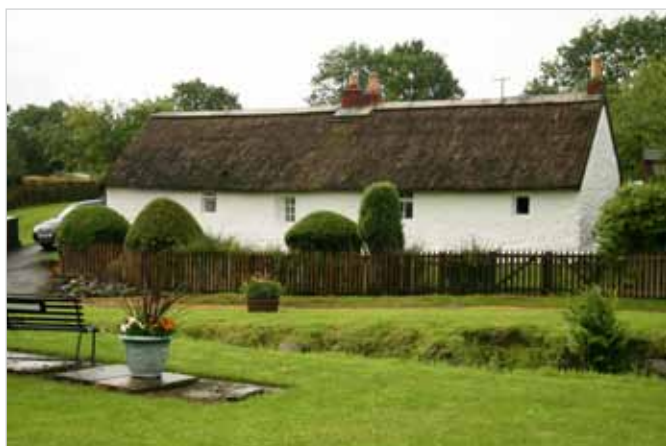
Farnbank Cottage – Perth & Kinross

Condition of Thatch: ..... Good

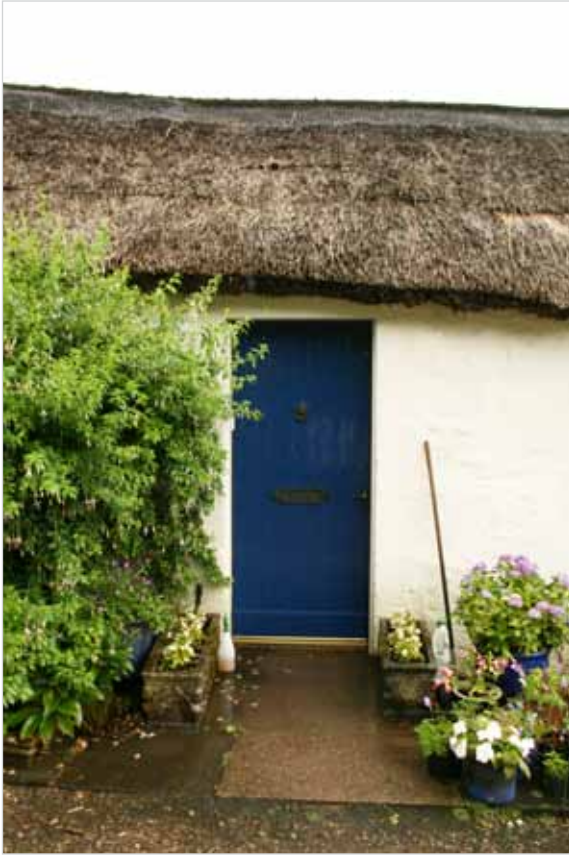
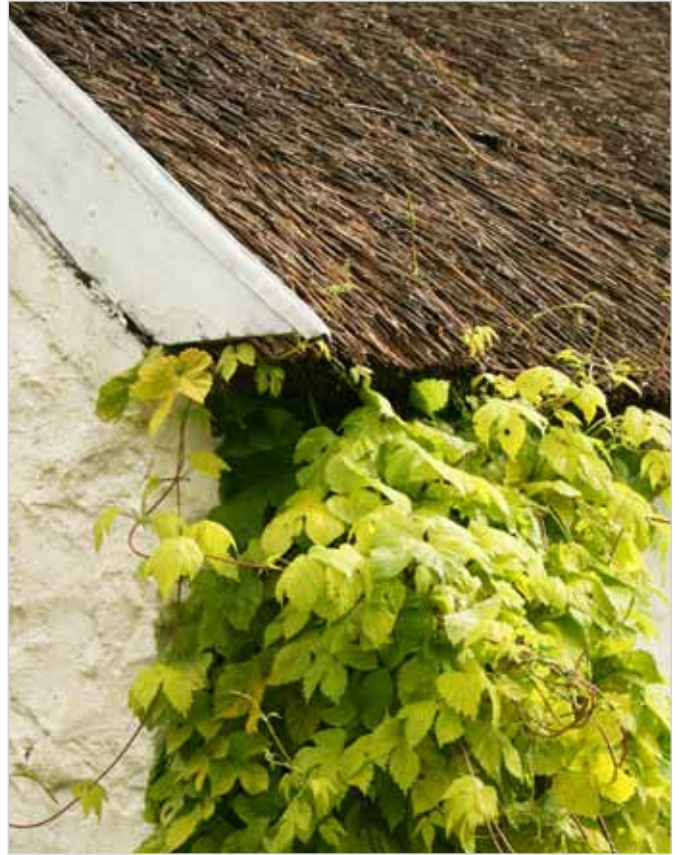
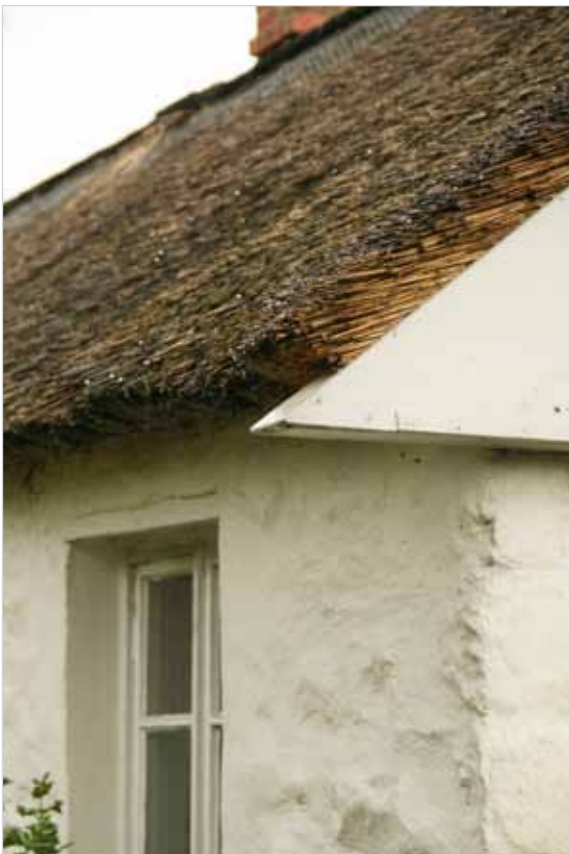
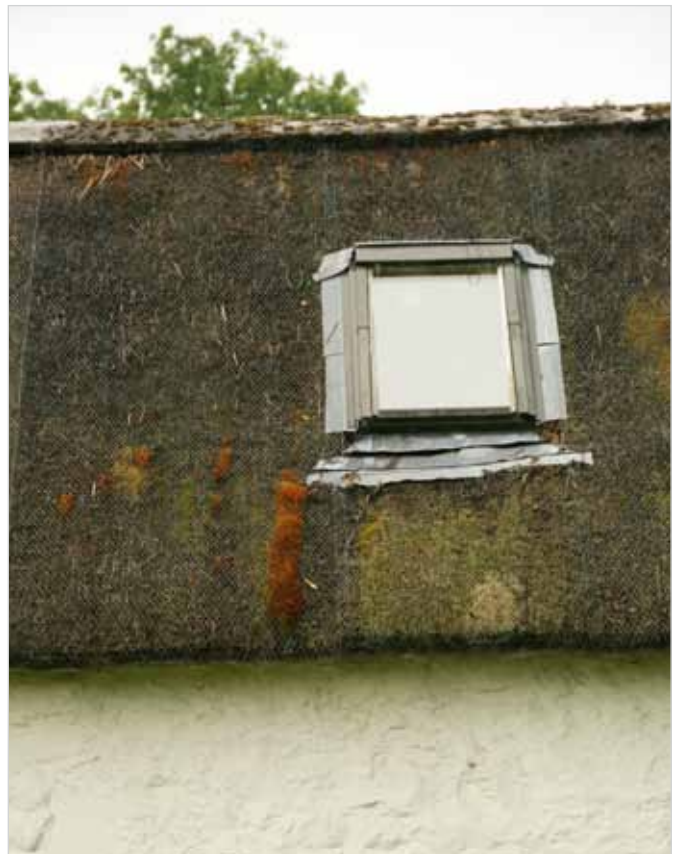
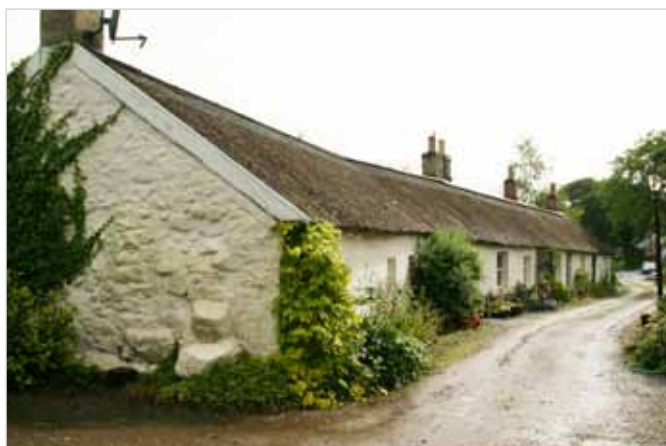
Glenview Cottage – Perth & Kinross

Condition of Thatch: ..... Good

Additional Notes: ..... 18th-century row of cottages, slightly curved in plan. The cottages have a continuous  
thatched roof, with a concrete ridge. On the front elevation the thatch is netted for about a foot directly below  
the ridge, with the rest of the thatch left uncovered, whilst on the rear elevation all the thatch has been netted.  
There is mossy vegetation growth on the surface of the thatch, particularly along the north (rear) elevation, and  
along the ridge. The thatch has been boxed in with timber at the skewes.

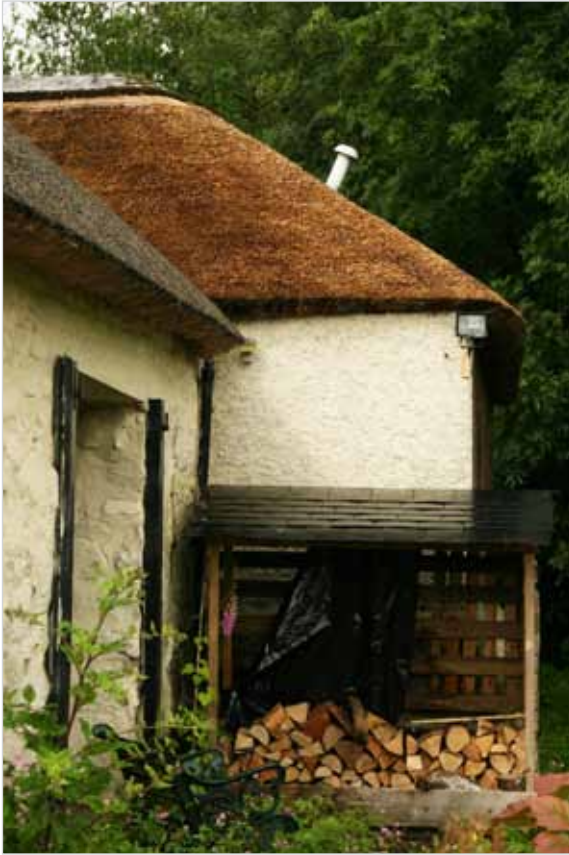
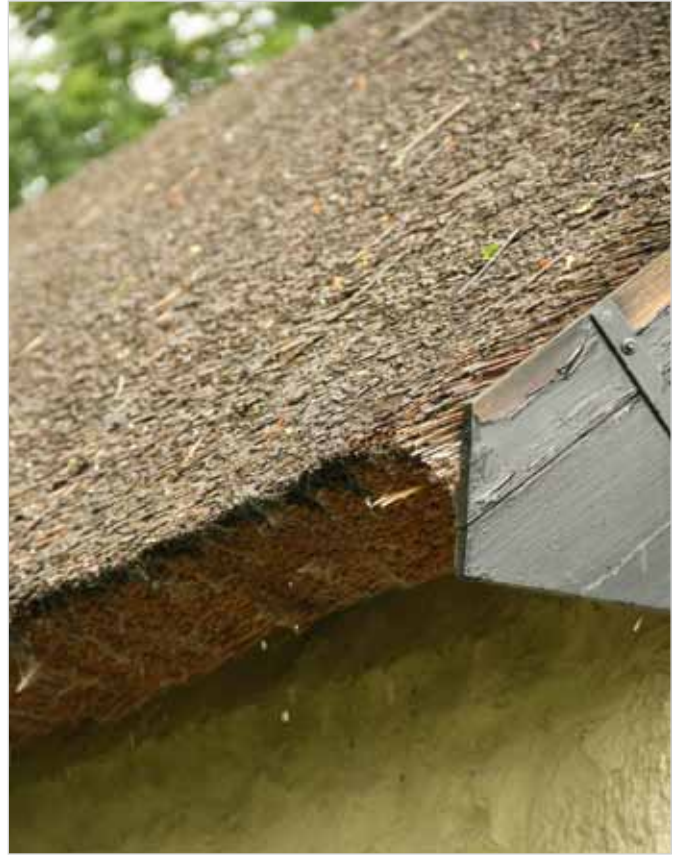
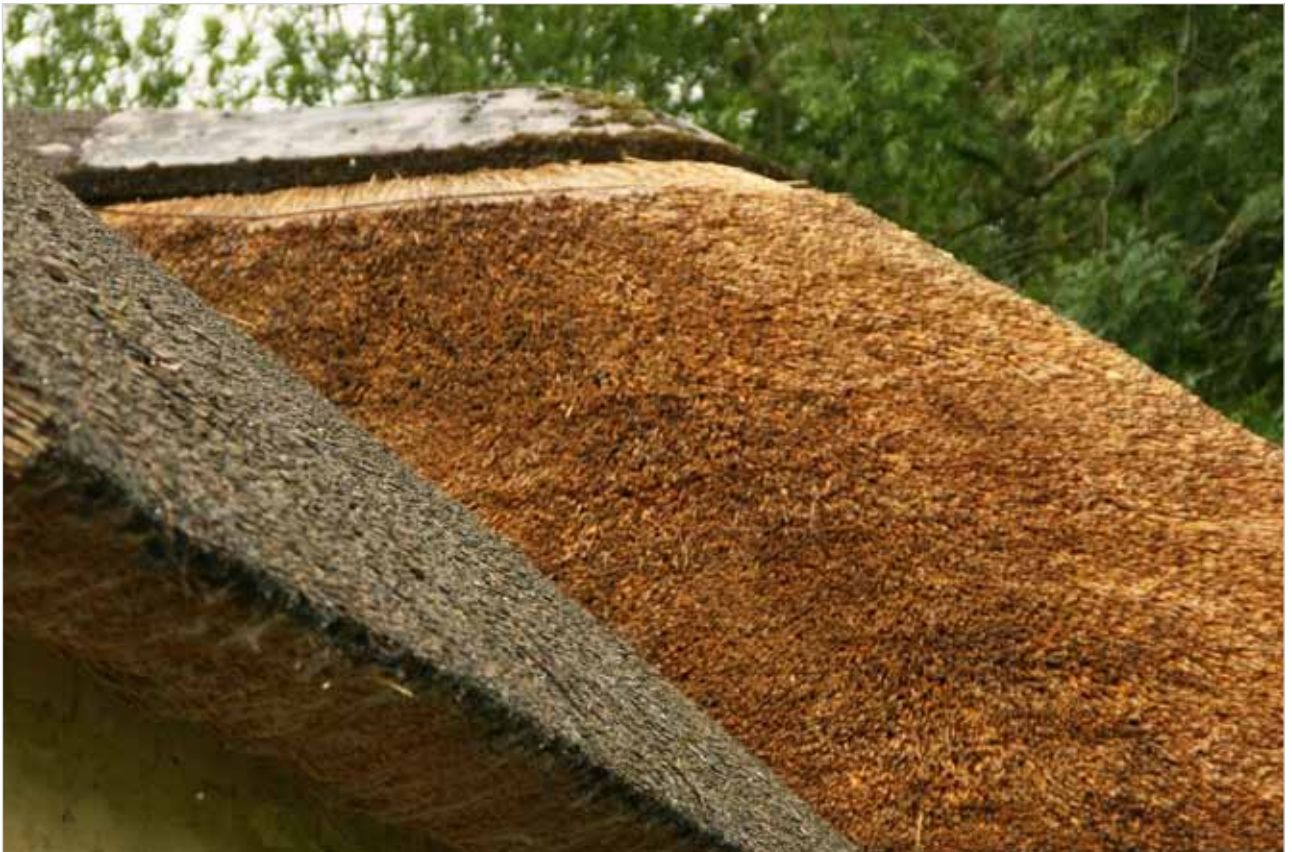
West End Cottage – Perth & Kinross

..... Good
